Systems Engineering Investigation of Navy Electrical Bomb Fuzing

Gary A. Evans (Naval Air Warfare Center, Patuxent River, Maryland)

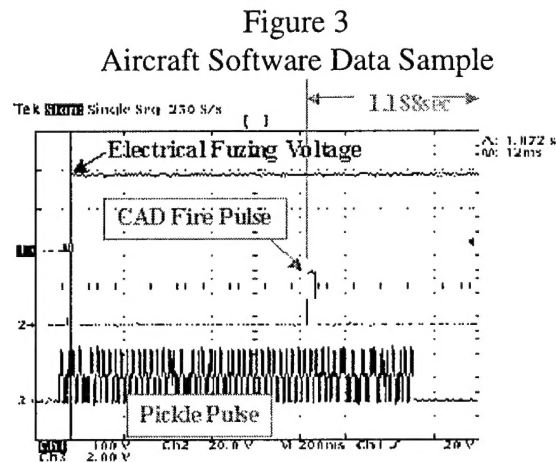
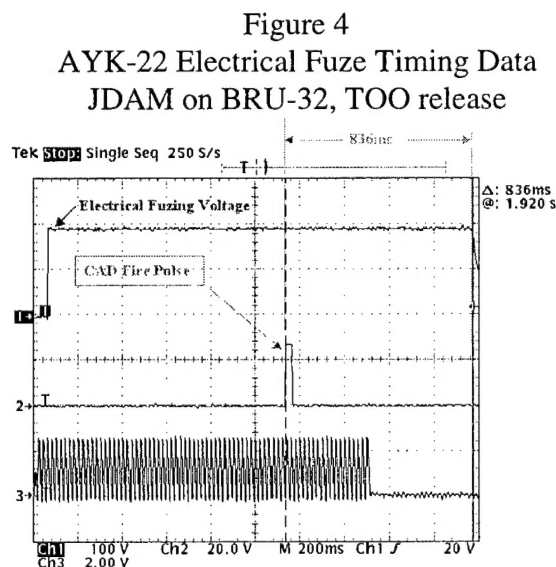
specified limits and of a sufficient duration and magnitude to fully arm the fuze. Figures 3 and 4 show software test data for the JDAM electrical fuzing signal. Both figures 3 and 4 indicate that the proper electrical fuzing signal was present prior to the bomb rack CAD firing. Sufficient signal remained until after the Mk 122 co-axial connector was extracted from the bomb rack connector.

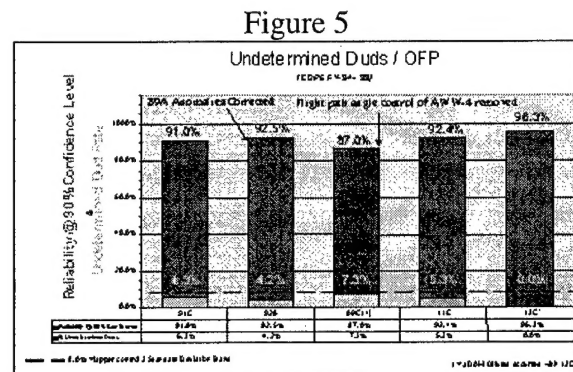
electrically fuzed bomb releases over a period of six years subsequent to the OFP fix. These data shown in figure 5, relate the undetermined dud bomb releases with the aircraft software present in the releasing aircraft. These data were then correlated with the software updates. This analysis identified that no correlation existed between unknown dud bomb rates and aircraft software changes. These operational data agree with the lab test results.

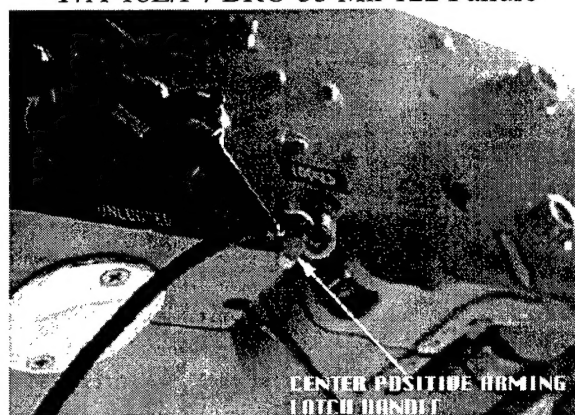
Figure 9
F/A-18E/F / BRU-33 Mk-122 Failure

Co-axial cable routing failures were identified during F/A-18E/F Engineering and Manufacturing Development (EMD) weapon separation testing. Post flight suspension equipment inspections found several instances of the Mk 122 co-axial cable returning with the aircraft after a weapon release. Figures 9 and 10 are post flight photos of the BRU-33 loaded on the F/A-18E/F. They identified two failure modes that are applicable only to the BRU-33 and Mk 82/83 bombs. The relative position of the BRU-33 rack lock/unlock handle to the co-axial cable of the Mk 122 coupled with flight air loads on the co-axial cable caused both of these failures. The air loads forced the cable against the side of the bomb rack unit. When the weapon is released the cable becomes hung-up on the bomb rack mechanisms. In figure 9 the cable became

trapped between the rack lock/unlock handle and the positive arm latch handle. This hang-up reduces the effective length of the Mk 122 coaxial cable relative to the lanyard. This failure would significantly reduce the duration of the charge time and may cause a dud bomb. Figure 10 shows a similar but more serious failure mode where the co-axial cable was forced by air loads to loop around the rack lock/unlock handle. This failure would prohibit the fuze capacitor from receiving its required duration charge signal of 15ms and result in a dud bomb. The aircraft contractor performed original weapon integration testing on the F/A-18A. Weapon components such as the Mk 122 were thought to be irrelevant and thus this failure mode was never identified.

type rack configured with an Mk 122 will be susceptible to the same failure modes. Alternate cable routings may eliminate or reduce these failures.

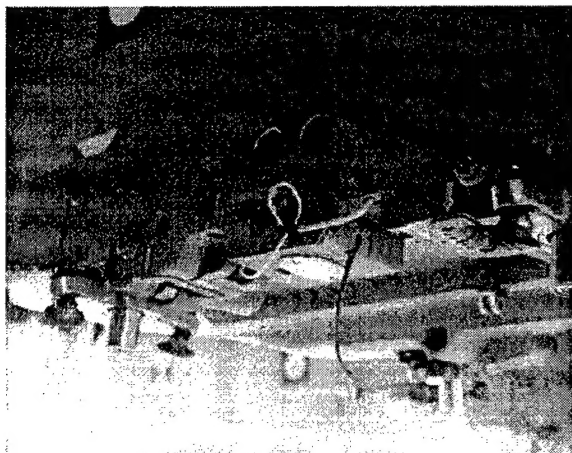
Figure 10
F/A-18E/F / BRU-33 Mk-122 Failure

From careful post flight examination the F/A-18E/F EMD known failure rate for cable hang-up was 2.2% that equates to a 97.0% reliability at a 90% confidence level based on eight recorded failures out of a total of 361 recorded test events. The failures were split evenly between 500 and 1000 lb bombs (4/181 Mk 82 and 4/180 Mk 83). Navy weapon integration standard operating procedures (SOP) increased the chances of finding these failures. After a weapon separation flight, the delivery aircraft was required to directly return for post flight armament inspections. Subsequent data analysis of COPE data has revealed an F/A-18 A-D known failure rate of 1.5% which equates to a 97.8% reliability at 90% confidence levels were based on three failures out of 195 data samples. The failure rate is almost certainly much higher as the evidence is easily lost in flight or on landing. This can be seen by close examination of figure 9. The co-axial cable connector has been extracted from the BRU-33 electrical fuzing connector and is ready to fall out. Therefore, co-axial cable hang-up will cause electrically fuzed bomb failures. This failure mode as stated above is only applicable to the CVER with Mk 82 and Mk 83 bomb bodies. Mk 82 and Mk83 JDAM mounted on the BRU-33 or similar CVER

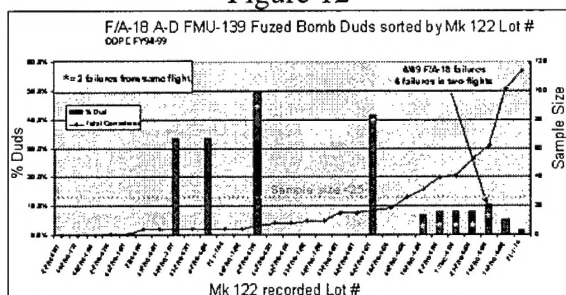
Figure 12

The majority of Mk 122 inventory is almost 30 years old. Switch function may be impaired by lubricant used in the switch that has degraded and migrated into areas of the switch it was not intended for. Original tests designed to verify the switch performance are no longer valid due to sticking brought about by age. Limited on-aircraft F/A-18 & AV-8B ground tests of two switch lots identified switch closure times in excess of the specification time of 2.5ms. Mk 122 Lot FII was greater than 4-5 ms and Lot TMC was greater than 7-7.5 ms. Switch delays reduce fuze charge time margin. Analysis of COPE data, figure 12, did not identify any particular critical lots of Mk 122 Safety Arming Switches.

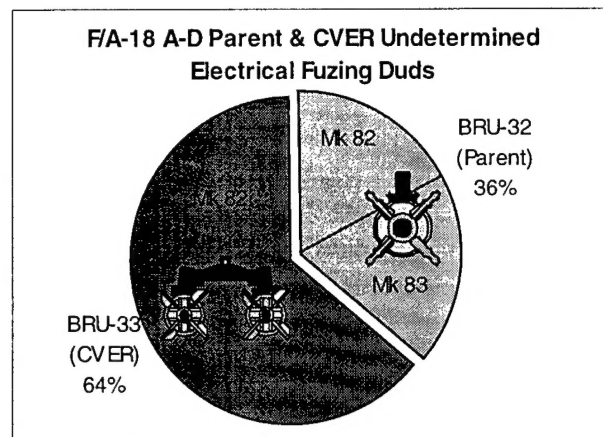
Figure 13

The BRU-32 and BRU-33 have some of the highest ejection velocities of current operational Navy bomb racks. From the analysis of Navy COPE data, figure 13, it was determined that 64% of the F/A-18 undetermined duds occurred when bombs were released from the CVER. Parent station undetermined duds were evenly split between Mk 82 and Mk 83 bombs. The COPE data sample for CVER was made up mainly of 500lb Mk 82 Bombs.

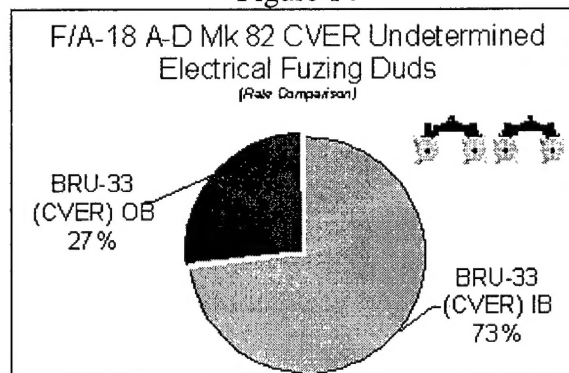
Figure 14

The largest percentage of undetermined duds from the CVER occurred from the inboard CVER station, figure 14 that is the second bomb to be released from the CVER.

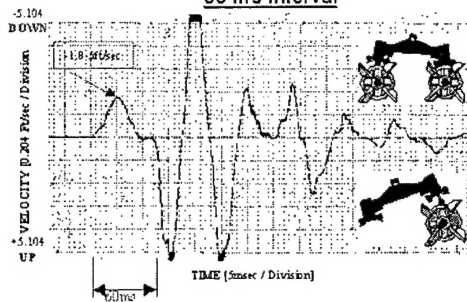
The CVER ejection dynamics are the greatest when only one store is loaded on the CVER as shown in figure 15. Ejector piston reaction loads force the CVER to pivot away from bomb as seen in figure 16. The reaction loads pivot the BRU-33 to an elevated displacement after the first bomb has already been released. In this configuration a roll rate is also imparted into bomb by the BRU-33 ejector feet. The combination of these dynamics shortens the time between lanyard pull and umbilical disconnect.

Figure 15
CVER Velocity During Ejection
60 ms Interval

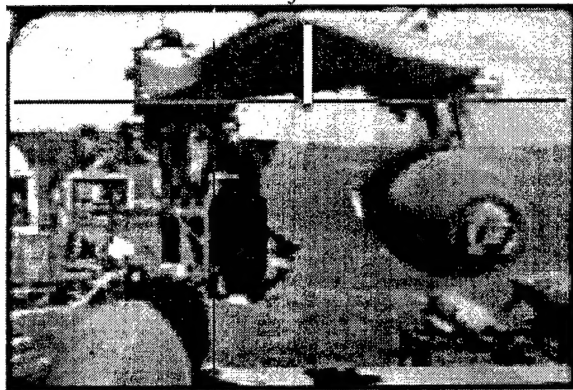
Figure 16
Mk 82 CVER Ejection @ 60 ms

It can also be shown from ground test data that CVER ejection dynamics change as a function of the release interval. The combination of CVER ejection dynamics and the roll rate imparted into the bomb reduce the Mk 122 co-axial cable connect time to the point where a bomb dud can occur for both 500 and 1000lb bombs on the CVER.

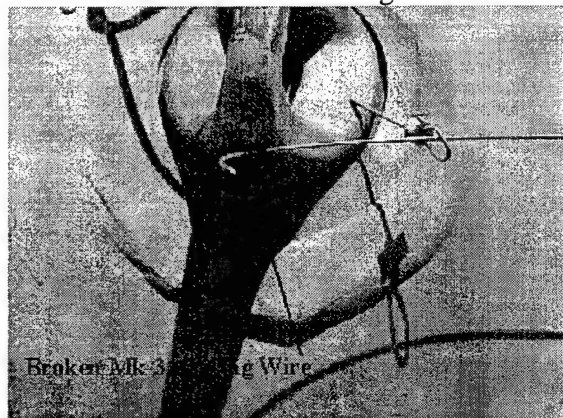
Several bomb failure modes have been attributed to the Mk 3 arming wire. First, the routing of the arming wire around the bomb lug makes it susceptible to damage if it becomes jammed between bomb rack hook and lug during loading, in-flight carriage, separation, and downloading as shown in figure 19.

Figure 19
Broken Mk 3 Arming Wire

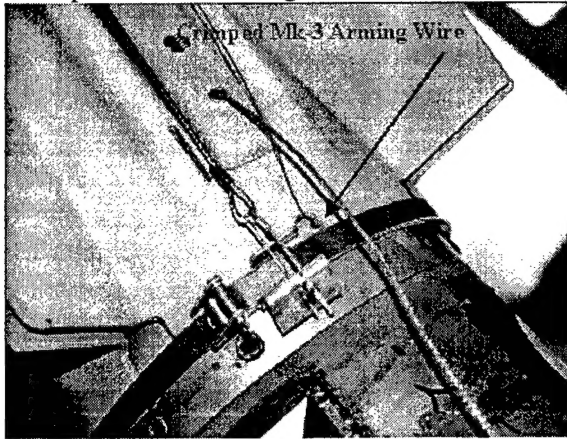
Figure 20

Another failure mode of the Mk 3 arming wire occurs when used in conjunction with the Mk 82 BSU-86 Tail Fin. The fin blade movement of the BSU-86 can cut or kink the wire during carriage as shown by figure 20. This failure mode has also been reported on Mk 15 fins.

Crimped Mk 3 Arming Wire on BSU-86 Fin

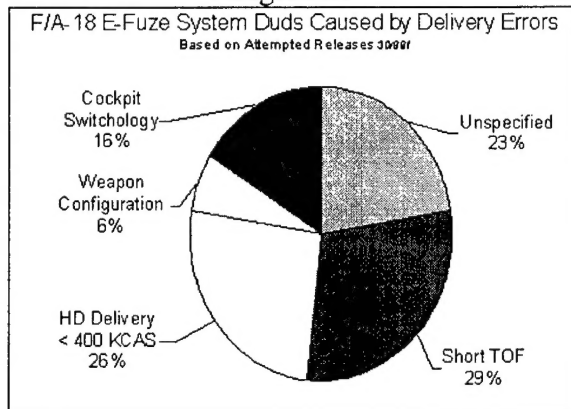
Figure 27

Delivery errors were reviewed and separated into categories in figure 27. Short time of fall (TOF) and delivery of high drag weapons at less than 400 KCAS account for the majority of delivery errors. Short TOF duds can occur prior to receipt of a dud cue. A dud cue is displayed on the heads up display (HUD) when the fuze arm time is greater than the aircraft calculated weapon time of fall. The time of fall for dud cue generation however does not account for fuze arm time tolerances. Therefore a short TOF dud can occur even though no dud cue is generated.
